STITT
PROFESSIONAL SPARK PLUG
INSTALLATION MANUAL FOR
INTEGRAL COMPRESSOR ENGINES

STITT®
SPARK PLUG COMPANY

A SET OF STITT "S-AG10-2" SPARK PLUGS & STITT "USL2A-18A" SAFETY-SHIELDED SECONDARY LEADS

The engine that we have selected to illustrate the proper procedures is a Clark Bros. (Dresser-Clark, Dresser-Rand)® TCVD12. This engine is a 2-stroke cycle, 450mm (17.72") X 483mm(19"), turbocharged, stationary, methane-fueled engine producing 6,000hp and driving integral compressors at 330rpm. The engine has been outfitted with precombustion chambers (PCC's) so as to produce cleaner exhaust emissions.

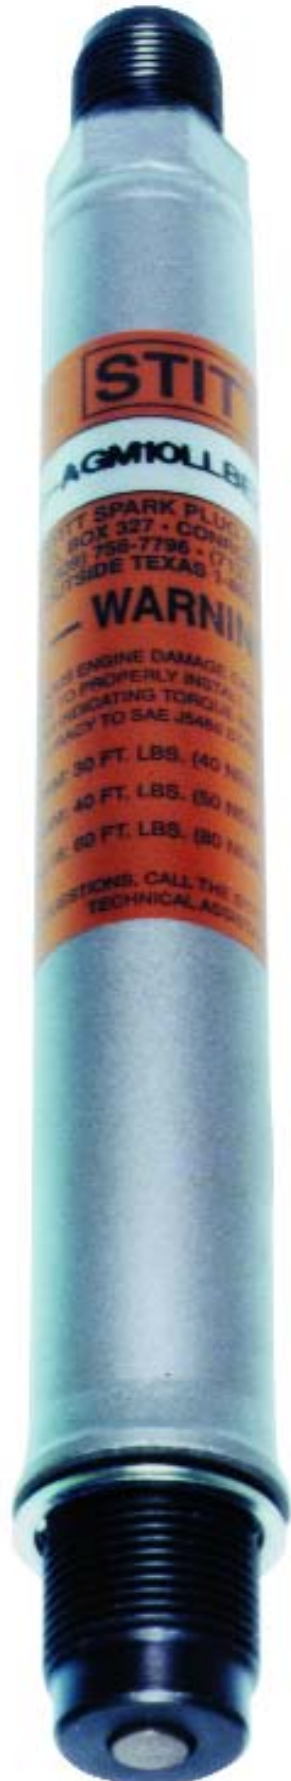
A representative example of the Stitt one-piece, extended-length spark plugs incorporating the “AG” [Annular Gap] firing-end configuration. This configuration is intended for usage in pre-combustion chamber applications, principally. For more information, we recommend that our Annular Gap Catalog be consulted.

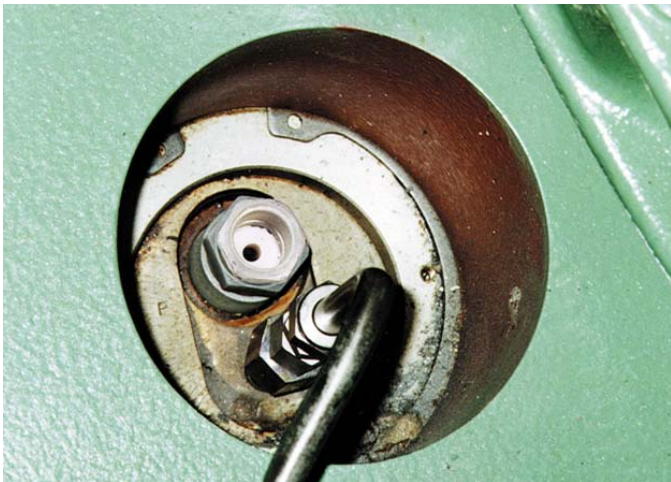
Cooper-Champion RW80N after experiencing Insulator break-up during operation.

Within hours of the initial "on-site" engine start-up, the engine operating company noted that the Cooper-Champion spark plug failures resulted in a predictable electrical arc-fault in a Class 1, Group D, Division 2 location. In addition to the extra operating expense of unscheduled downtime required to replace the broken spark plugs.

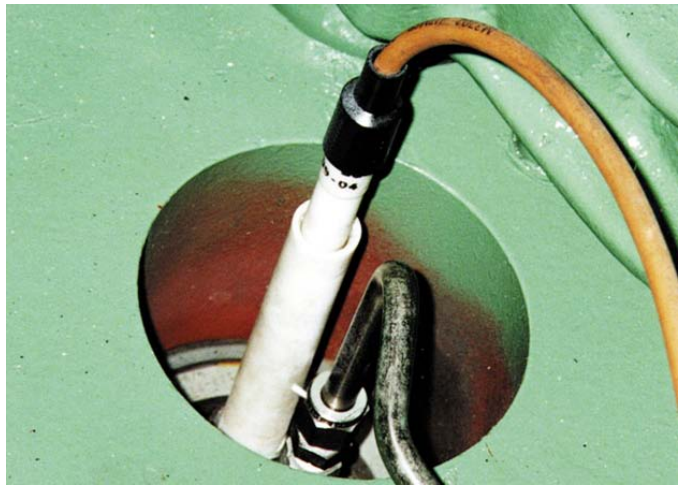
Dresser-Rand factory configuration.

Also, the engine operating company noted that the engine manufacturer's component specification would result in a predictable dielectric puncturing of the plastic (Teflon) in a Class 1, Group D, Division 2 location, with an external arc-site forming from the spark plug to the fuel gas check valve (gas admission valve).

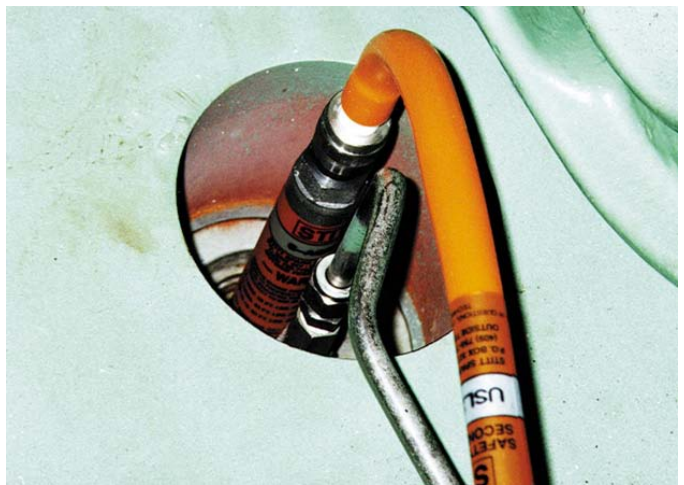
Stitt S-AG10-2 spark plug and Stitt USLA-18A Safety-Shielded secondary lead fitted to Dresser-Rand TCVD precombustion chambers.

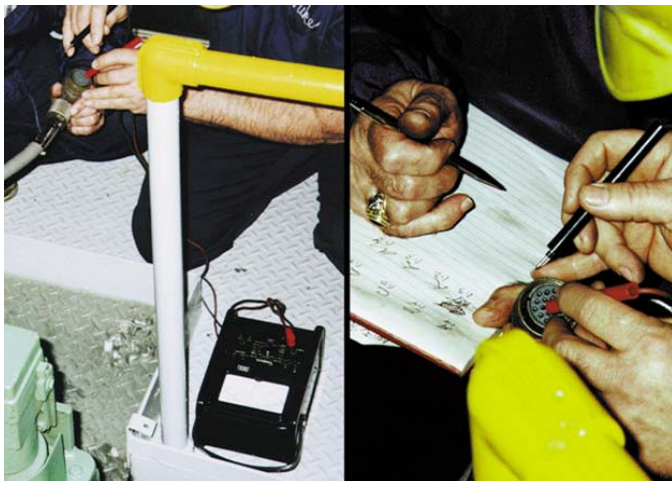
This very simple and fast examination of primary ignition circuit resistance values (Ohms,) revealed that the resistance levels for one cylinder were out of specification (too high). For this cylinder in the firing-order, the spark plugs were going to have a more difficult time being supplied with output energy from the ignition module. And though that is indicative of a primary wiring problem that should be corrected, that would have to take place at a later date when extra engine downtime could be scheduled.

What this examination did confirm is that all the primary wiring had continuity based on this ignition component manufacturer's specification. The ignition coils were all receiving input energy from the capacitors in the ignition module.

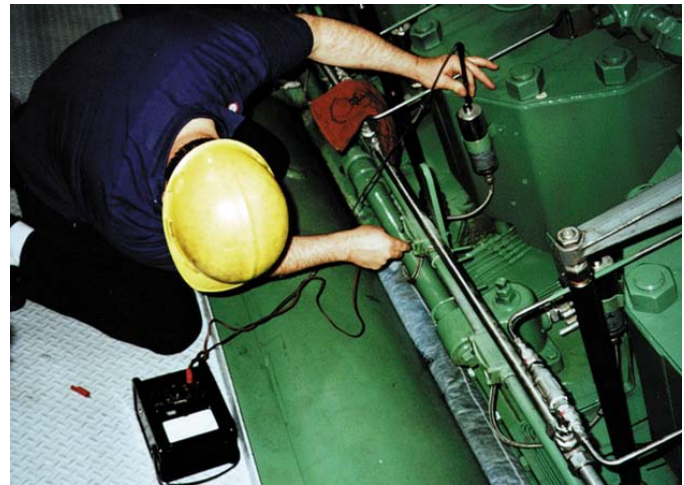
Two of the ignition coils were found to be non-functional. For this engine, that meant that one precombustion chamber was "dead" in two different cylinders. The spark plug could not fire because the coil was unable to supply it with energy.

The "dead" coils were replaced at cylinder 2L, "Left-side precombustion chamber" and 2R, "Left-side precombustion chamber". Having identified and corrected the major deficiency with the upstream ignition components, the spark plug installation went forward.

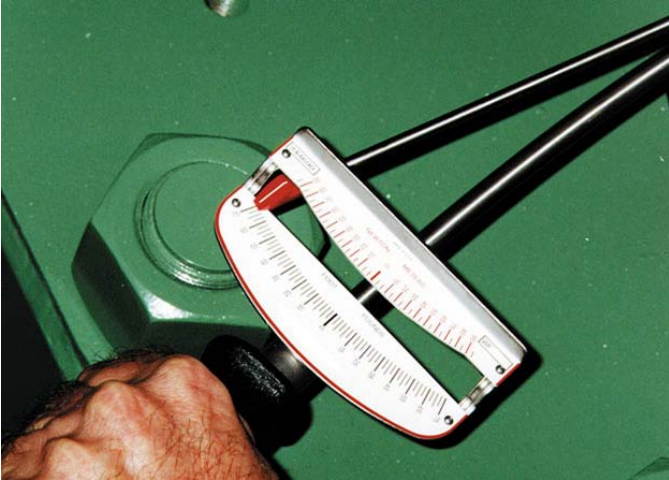
For this reference installation, we wanted to measure the “breakaway” torque required to remove each spark plug. Using a balance-beam style of torque wrench, here are the indicated results. The limit on this Stitt Torque Wrench is 75 ft. lbs.

It should be noted that certain spark plugs could not be loosened at the maximum level (75 ft.lbs.) that can be indicated by our recommended style of torque wrench. Other spark plugs required either no breakaway torque or an excessively low level of breakaway torque: these were only hand-tight in the precombustion chambers. These extremes of abnormal spark plug tightness can be revealing of conditions that can cause serious spark plug operating problems.

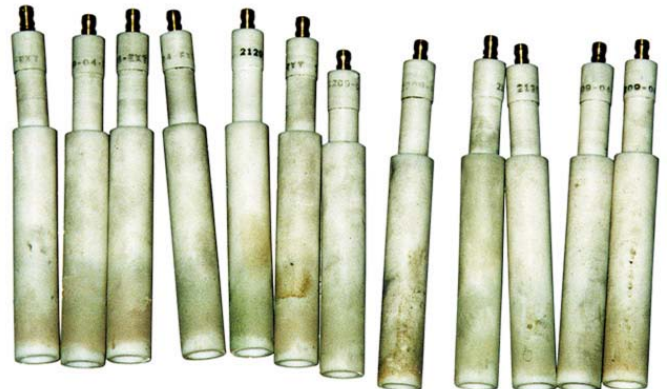
Plastic (Teflon) extension assemblies removed after approximately 1,500 hours of operation. In even this short a period of time, the thermal distress exhibited in the bottom two inches (50.8mm) would indicate to us that these components are running up on the requirement that should call for their replacement if emissions critical operation is to be assured.

The reason for this level of inspection is because Teflon, like all polymeric materials, deteriorates over time when exposed to certain temperature levels. In this application, where the Teflon is attached to an operating spark plug in a stationary engine application, the continuous exposure to elevated operating temperatures will accelerate Teflon's loss of electrical insulation capabilities.

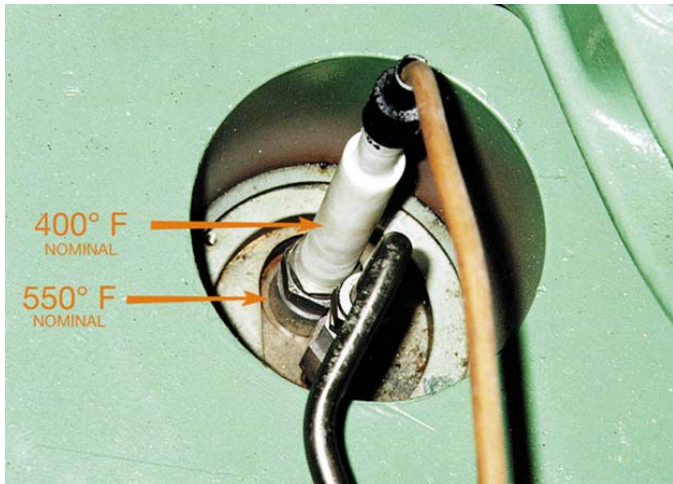
Temperatures in the areas of a spark plug and extension assembly in an operating, stationary engine.

In fact, virtually from the time this plastic material was first put into service on this engine, it was subjected to an operating temperature level that exceeded the Underwriters Laboratories Temperature Index for Teflon (PTFE), 356°F (180°C). Essentially, this Index identifies a polymeric material's maximum continuous-use temperature under very low continuous or low intermittent stresses in applications requiring maximum retention of the desired properties. In this case, the desired property is electrical insulation. But in this ignition application, the stresses are high continuous and the requirement is maximum retention of the desired property. Recognizing this, the short performance life of Teflon under these conditions must be considered.

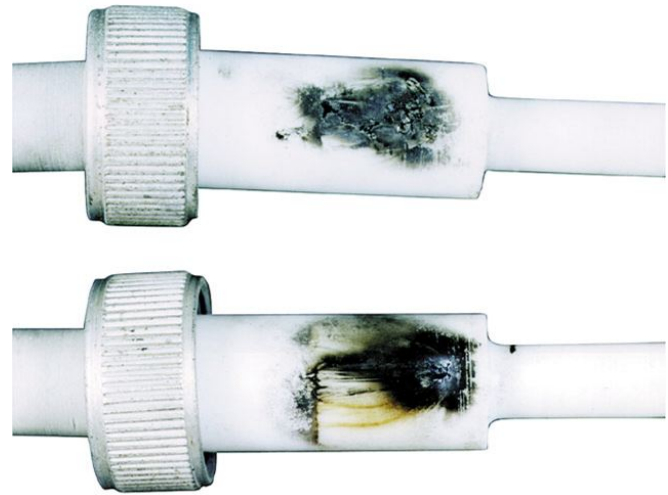
Some industrial ignition component manufacturers offer only plastic terminations at a favorite price. This photograph is of a major ignition system component manufacturers plastic (Teflon) insulators exhibiting dielectric puncturing. This common style of insulation failure in this location should be of major concern to the engine operator. It causes misfiring, of course. Not a desirable situation for an emissions critical gas engine. It should be noted that these insulation failures are occurring at a location that operates at temperatures hundreds of degrees cooler than the same material that is electrically insulating the high voltage connection to the spark plug.

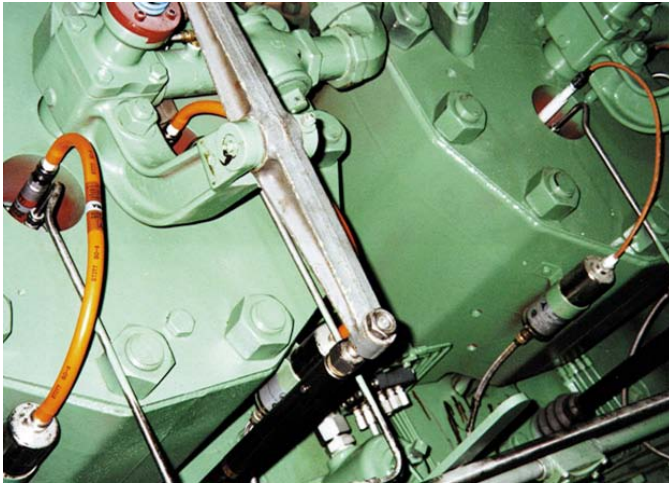
STITT Replacement Components

1. STITT S-AG10-2
2. STITT USL2A-18A Safety-Shielded Secondary Lead

1. Cooper-Champion RW80N
2. Teflon Extension Assembly
3. Secondary Lead

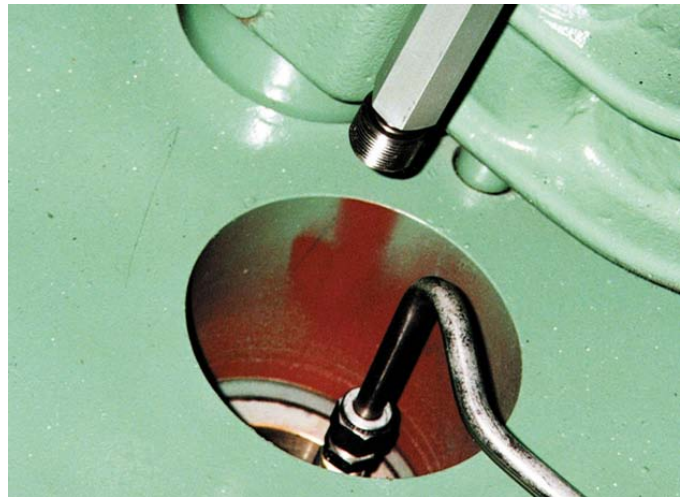
For the subject TCVD12, the NO GO gauge could not be threaded into any spark plug port. Based on this result, it can be safely recorded that no precombustion chamber has an oversize port.

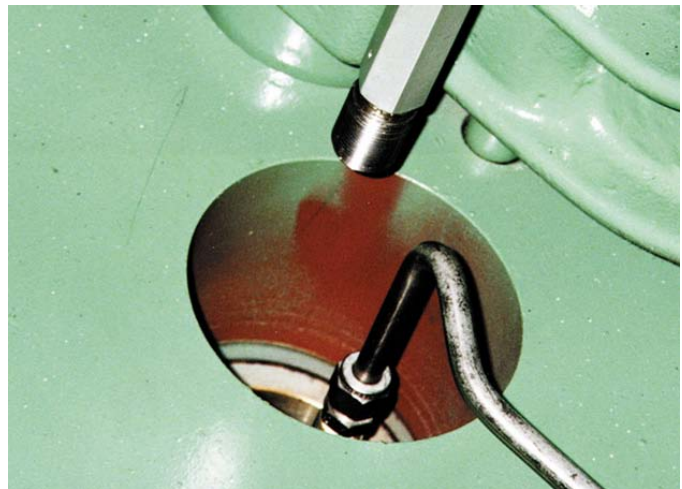
For the subject TCVD12, the GO gauge could not be threaded into sixteen (16) of the twenty-four (24) spark plug ports. According to the gauge, only two (2) cylinders (1R & 4R) had a pair of properly dimensioned spark plug ports. And that probably explains why the engine operator routinely used thread lubricant. The operator, never having gauged these threads before this installation, had always thought that spark plug "sticking" was a spark plug problem. Little did the operator realize that the heart of the "sticking" problem probably resided in the spark plug port threads as were furnished by the engine manufacturer. In fact, in the light of our findings concerning spark plug port dimensioning, it might be said that many engine operators are using thread lubricants to facilitate spark plug installation.

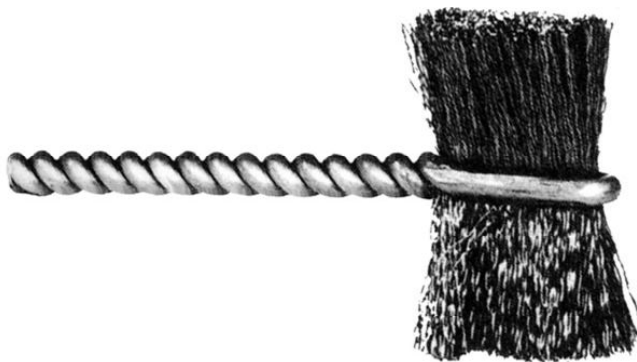
BR78 Clean-Out Brush.

To completely and safely clean a spark plug port without dismantling the engine, the only tool that we can

recommend is one of our spark plug port Clean-Out Brushes. These are fabricated from fine wire steel and are dimensioned for each principal industrial spark plug thread size (14mm, 18mm, 7/8"-18).

For the TCVD12, the BR78 would be used with the BH2 brush holder and two (2) BX6 brush holder extensions.

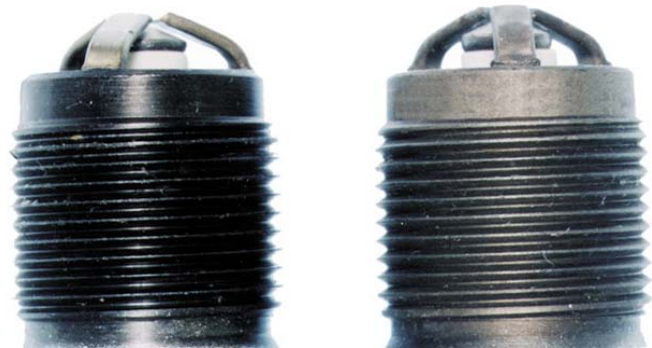
Regular STITT Black Oxide Finish

"NP" suffix-designated surface for enhanced anti-galling properties. This vacuum-deposited preparation consists of a tribo-logical linear bearing surface of nickel-silver-palladium.

But, if an extra measure of anti-galling protection is desired, then we can only recommend that our factory-applied, ion-implanted, nickel-silver-palladium, linear bearing, surface finish, spark plugs be installed. We consider this surface finish to be the only anti-galling treatment currently available for spark plug threads. No electroless nickel, no zinc chromate, no electrolytic copper-nickel methods of surface finishing offer any equivalent level of anti-galling protection to this uniquely Stitt process.

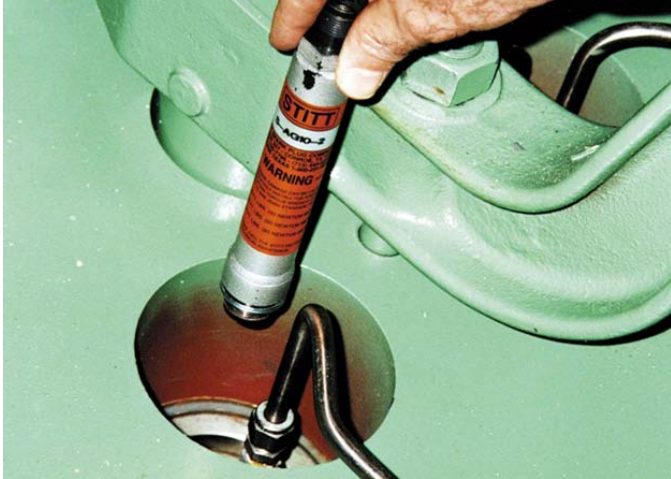
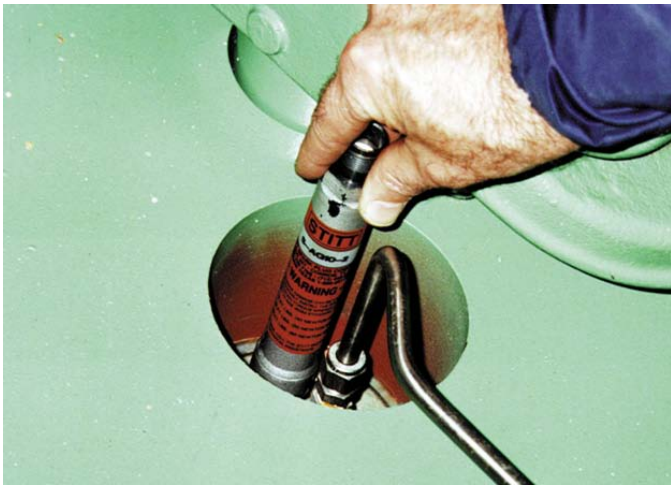
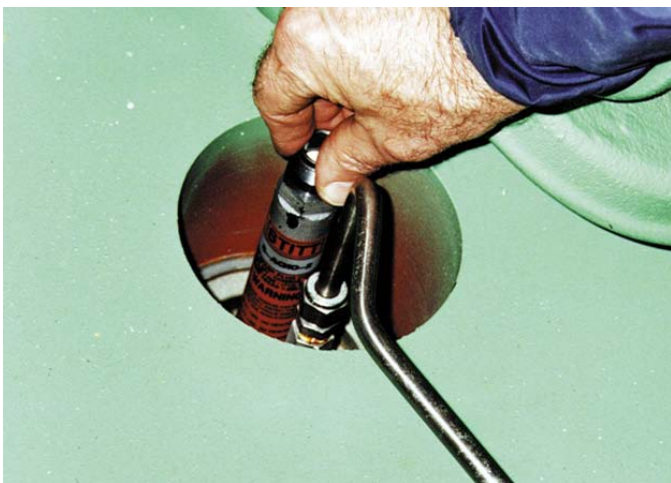
3. The proper procedure for fitting a spark plug is to thread it to the external seat gasket position by hand. For the deep spark plug well cylinder head, only Stitt offers a spark plug that allows this proper installation procedure.

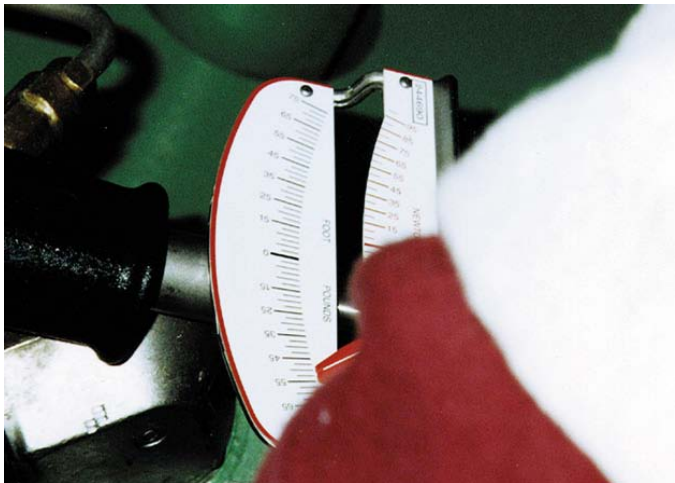
5. After the spark plugs have been secured into the cylinder heads by the application of proper installation torque, then the STITT silicone-insulated, Safety-Shielded Secondary Leads (USL2, ESL2, RSL2 series) can be connected to the spark plugs and the ignition coils.

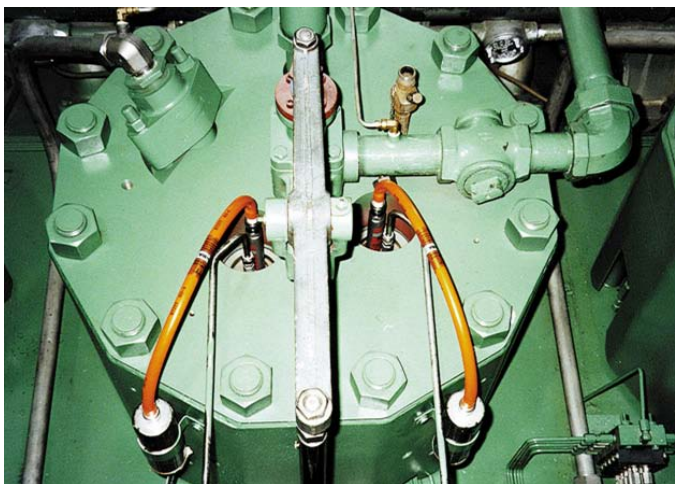
STITT S-AG10-2 Spark Plugs and the STITT USL2A-18A Safety-Shielded Secondary Leads installed and ready for start-up

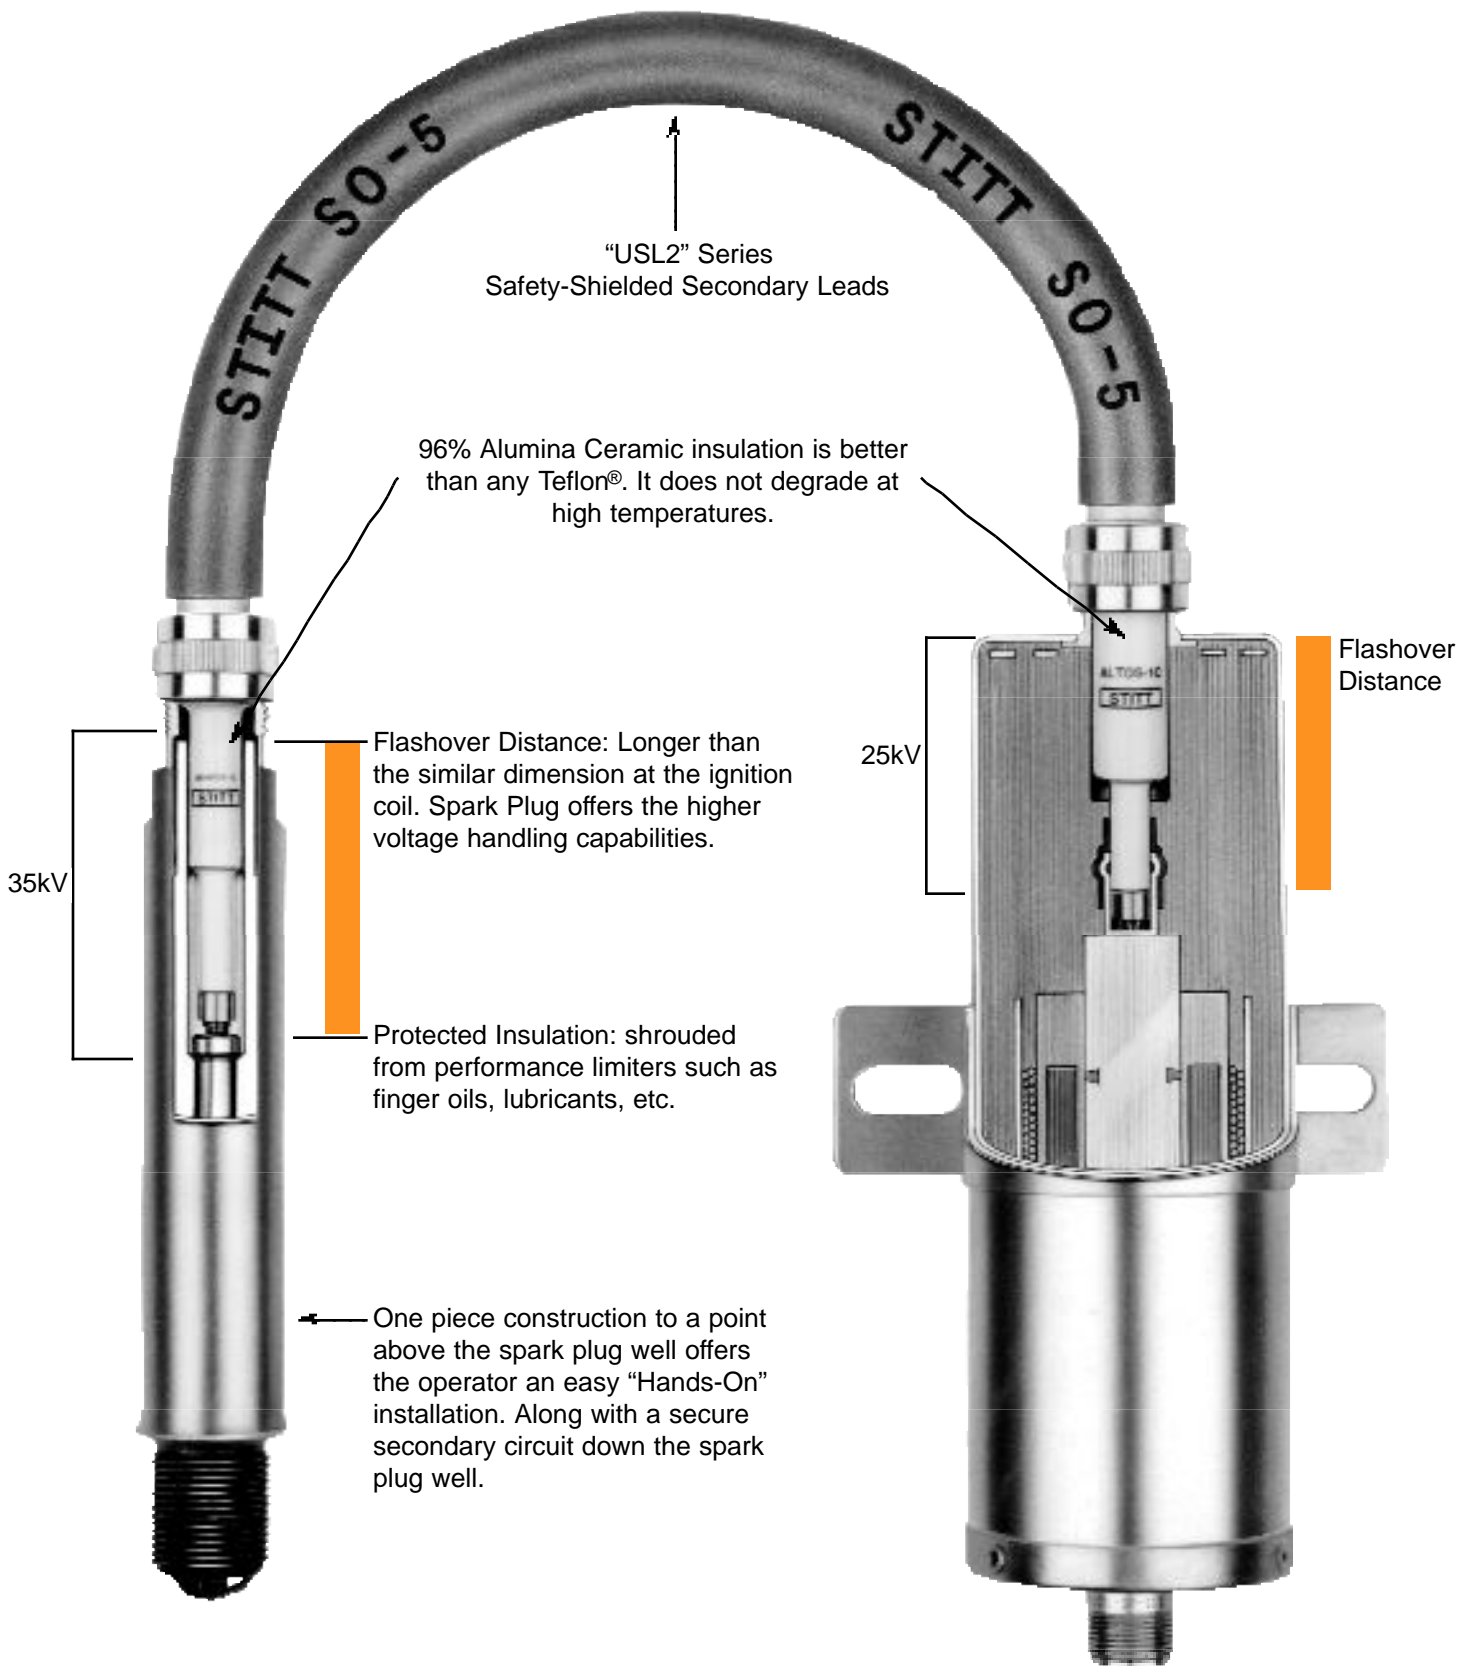
STITT S-R707-2
Spark Plug

STITT USL2A-12A
Safety-Shielded Secondary Lead
